CASE STUDY ON THE DETERIORATION OF PIVOTS IN OPERATION

Case study on the analysis of wear and damage of automotive pivots in operation.

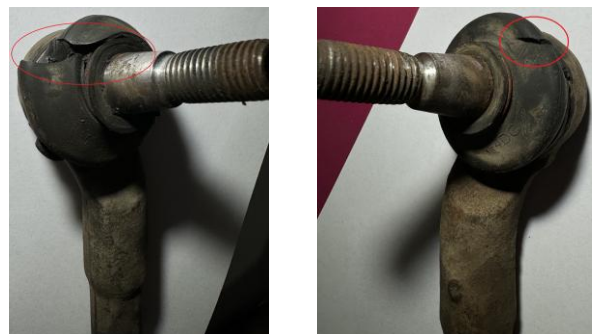
The "H" vehicle from the year of manufacture 2000 had bar ends with damaged dust cover, which led to replacement of the ball joints after 45,000 km in operation.

Figure 1: Damaged bar ends due to the dust cover cut of vehicle "H"

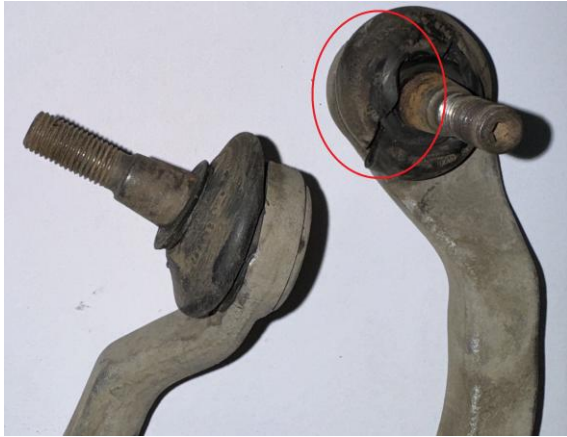
Vehicle "A" from the year of manufacture 2008 had bar ends with damaged dust cover after 35,000 km of use.

Figure 2: Damaged bar ends due to the dust cover cut of vehicle "A"

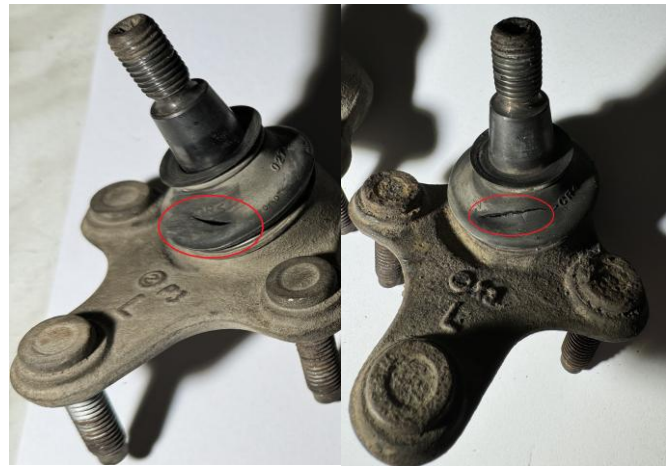
Vehicle "B" from the year of manufacture 2006, had original pivots that were subjected to significant wear after 188,500 km of use, which led to the need for their replacement.

Figure 3: Worn ball joints of vehicle "B"

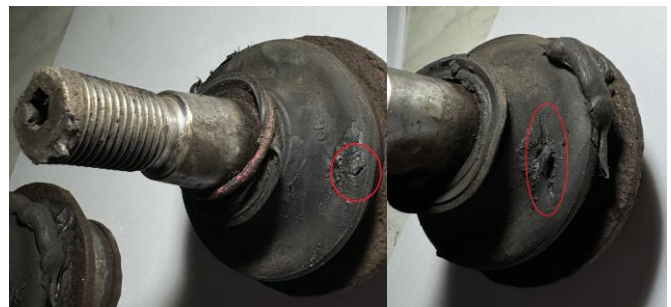
Vehicle "E" from the year of manufacture 2009, after 80,000 km of use, there were signs of wear on the pivots which affected the vehicle's performance.

Figure 4: Worn ball joints of vehicle "E"

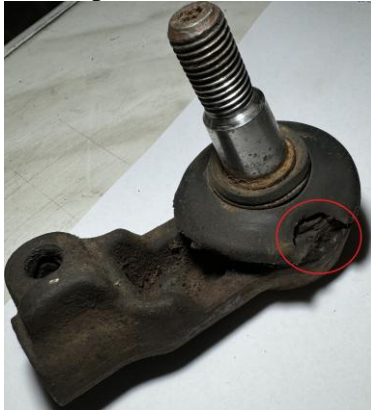
The "F" vehicle from the year of manufacture 2003, used on rough roads, showed signs of corrosion of the pivots after 38,500 km of use, especially in conditions of increased humidity and dust, which led to the need for their replacement.

Figure 1: Ball joint of vehicle "F" with broken dust cover
