DESIGN AND CONSTRUCTION OF A STAND FOR CHECKING THE SHAPE DEVIATIONS OF BRAKE DISCS

Abstract: *The wear of brake discs and their deformation during operation, due to various causes (sudden cooling due to contact with water, overheating due to frequent operation of the braking mechanism in a short time, etc.) is a common problem in the automotive industry. The purpose of this paper is to find an optimal solution for checking the deviations from the flatness of the brake discs, in the most usual form, by devising a method of making a device that allows measuring, checking and processing data in real time. The design of this device, along with the execution drawings, were created using a 3D program. In the introductory part, a current state of the art for brake unbalance checking devices was made, highlighting existing methods on the market, carried out up to now. An optimal but also functional variant of the device was adopted and organological calculations were carried out together with the technological route of one part of the whole assembly, namely the cone shaft. The description of the aspects regarding the realization of the installation and mentions of maintenance and operati

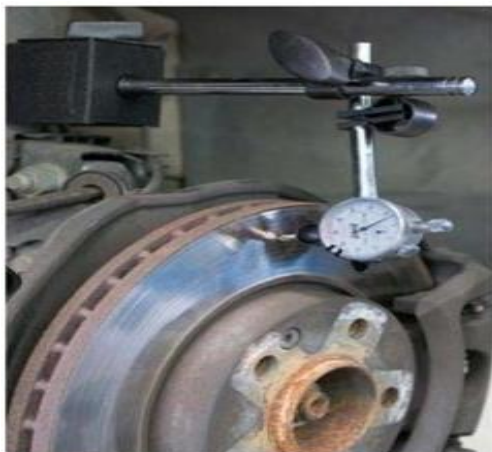
Figure 2: Checking with the comparator clock

An effective method of checking the deviations from the flatness of the brake discs is the checking of the flatness by means of dial gauges represented in figure 2.

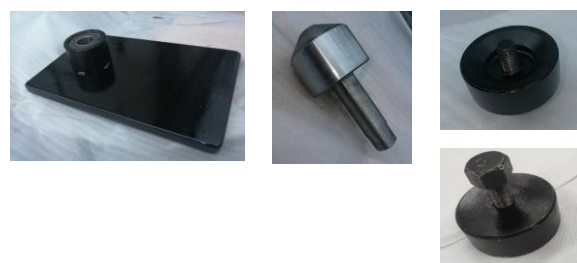
a) Base plate with support bushing and bearing b) Cone tree c) Fixing cover bottom view and top view

Figure 4: Stand components

After carrying out the organological and technological calculations, or choosing the materials for the actual construction and opting for an C45 steel presented in table 1, for the construction of the stand components represented in figure 4.

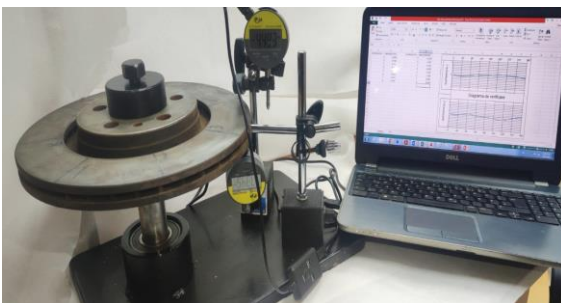
Figure 5: Device assembly

This involved marking eight points on both surfaces of the disc at an equal distance from each other, adjusting the clocks from the zero point, then rotating the brake disc so that the feeler could be brought into contact with the surface of the disc over all the points drawn. The precise fixing of the comparator clock was taken into account to avoid the appearance of errors.

The procedure involves measuring at eight points on both sides and noting the deviations on the check chart. Having the data on the diagram we can determine the maximum deviations with the data given by the manufacturer

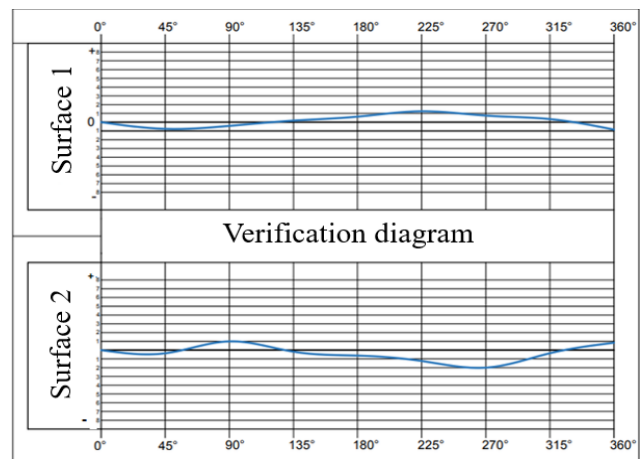
Figure 6: Ovalization values verification chart

The measurements performed are presented in table 2 and based on them, the ovalization values verification diagram represented in figure 6, of the brake disc studied on the two flat faces (surface 1, surface 2).

According to the resulting verification diagram, the deviation found in the case of the brake disc subjected to measurements does not fall within the limits prescribed by the manufacturer according to the published technical documentation which provides for a maximum deviation of 1.5 – 2mm.

The biggest deviations were recorded in the case of sections 5 and 6, where a difference of 2.5 mm and 2.9 mm resulted, respectively.
